Pressure offsets in Argo floats

Brian King

National Oceanography Centre
Southampton, UK

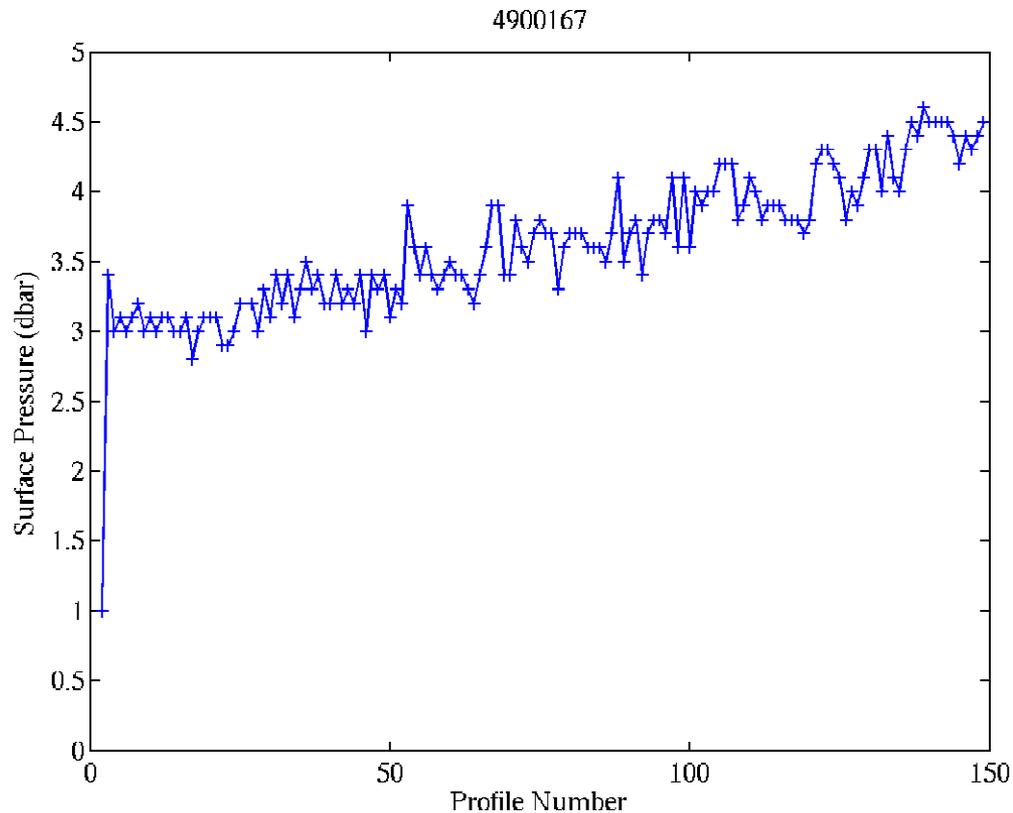
Figure 1. Reported sea surface pressure (SSP) vs. profile number from Argo Float 4900167, an APEX 260 with APF8 controller and an Ametek pressure sensor located in the Bering Sea. Note that even in the Bering Sea, the RMS variation about the long-term drift is a few tenths of a dbar.

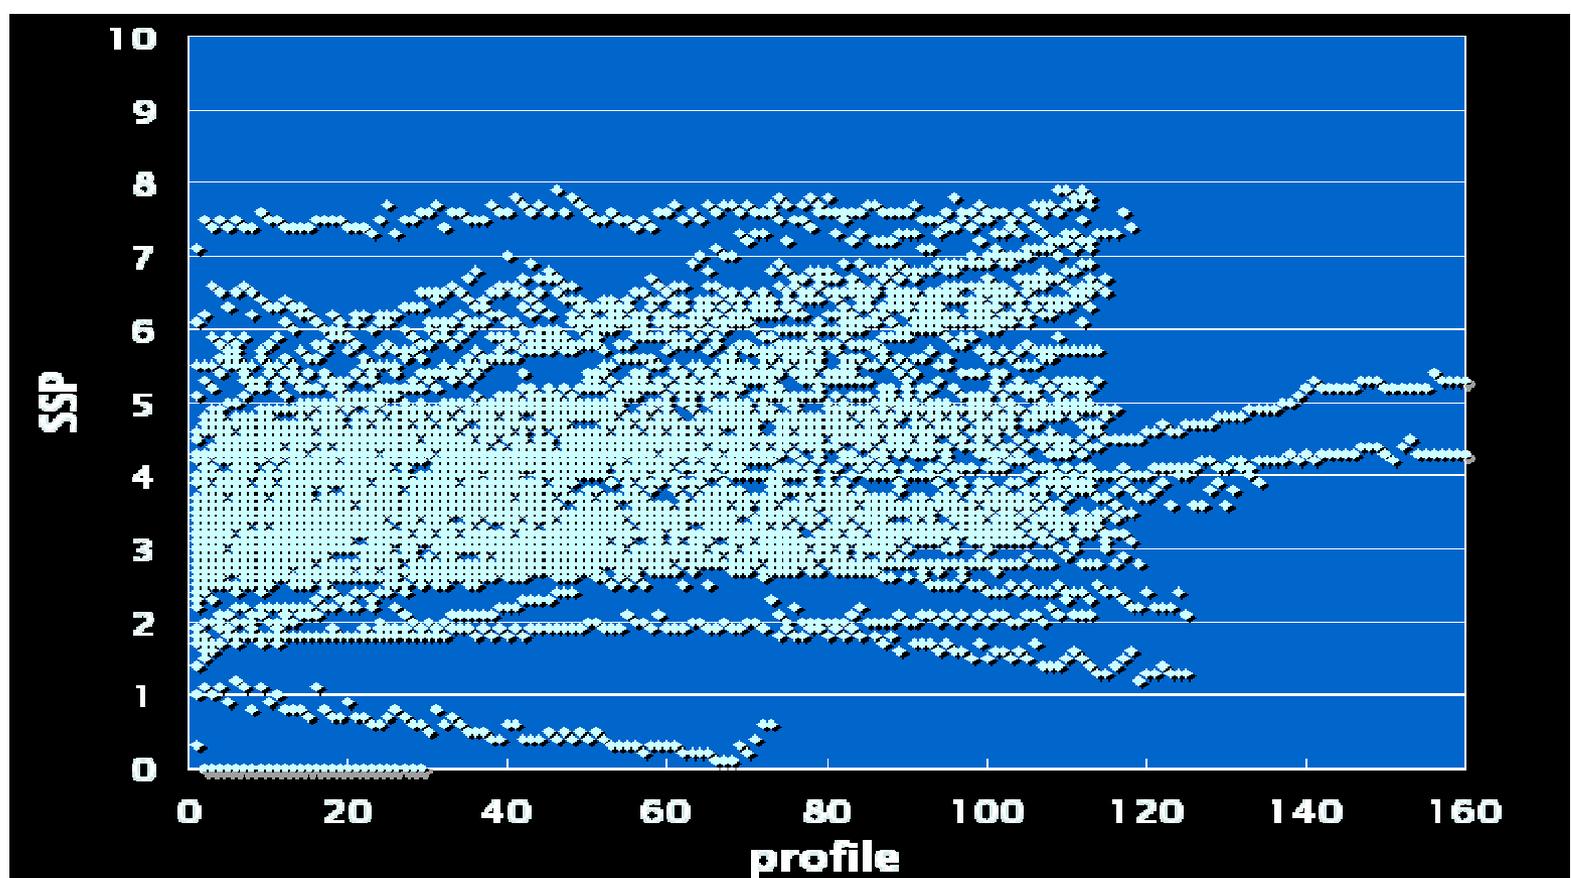
Figure 2. Reported sea surface pressure (SSP) vs. profile number from JAMSTEC Argo Floats equipped with Ametek pressure sensors.

All Ametek and Paine pressure sensors on APEX floats **should be adjusted** for the surface offset. The offsets are nearly all positive and significant.

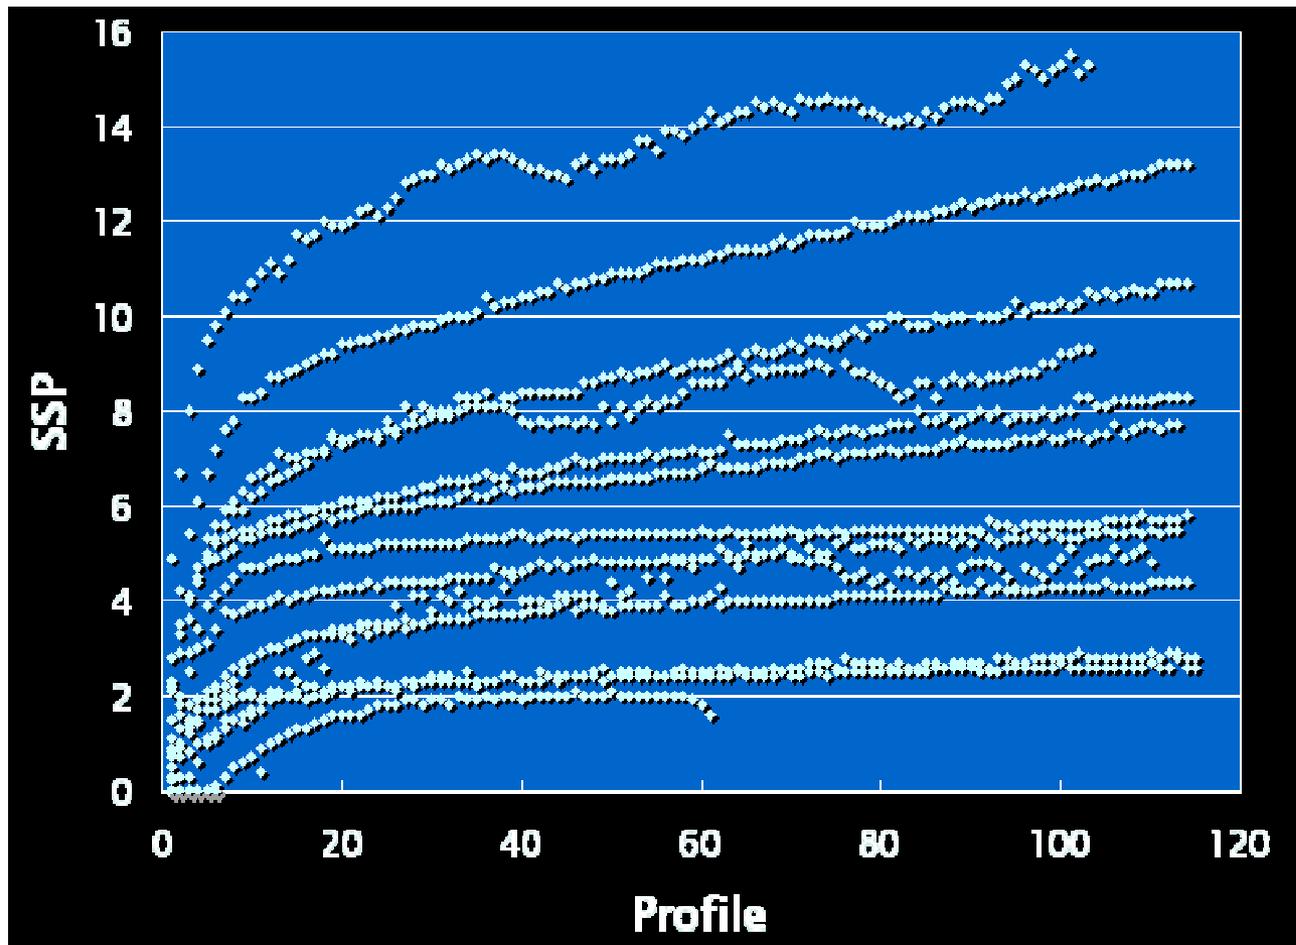
- Figure 3. Reported sea surface pressure (SSP) vs. profile number from JAMSTEC Argo Floats equipped with Paine pressure sensors.

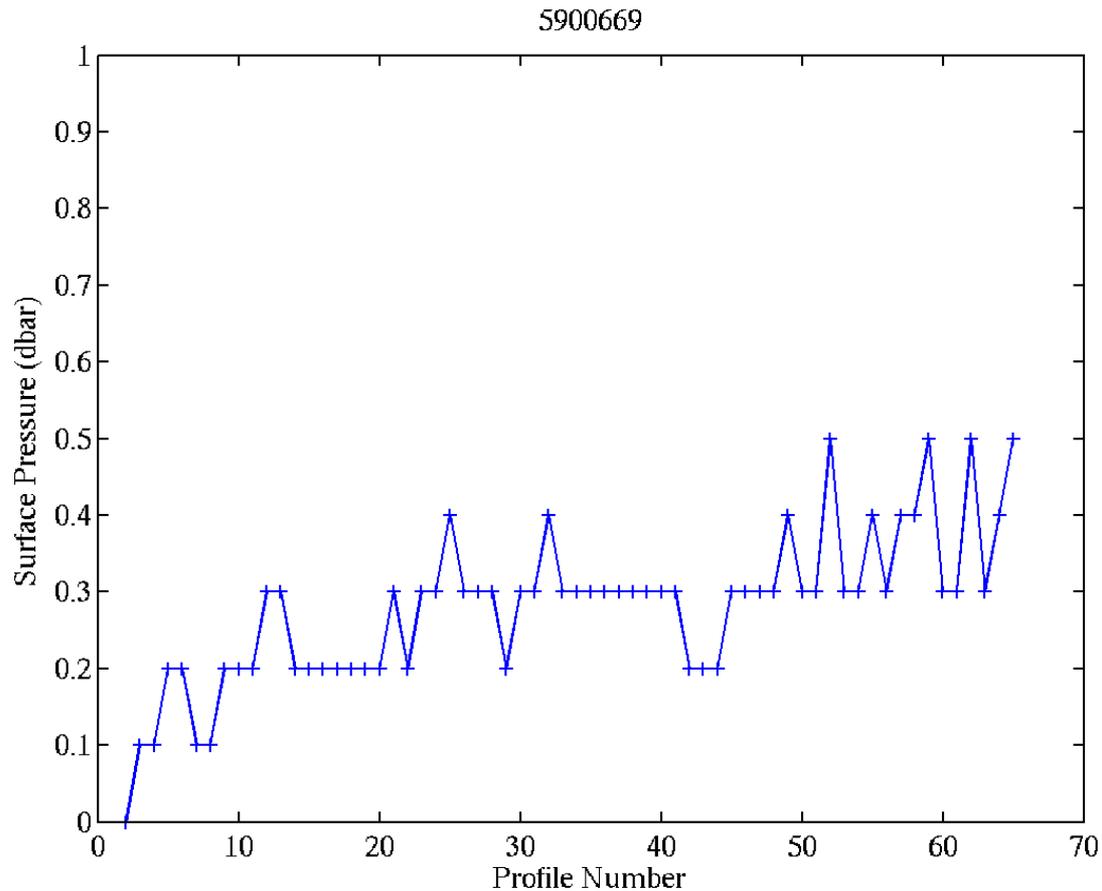
191 PMEL APEX with Druck pressure

51 apparently negative offset

36 apparently near zero

104 apparently positive, but small < 1 dbar

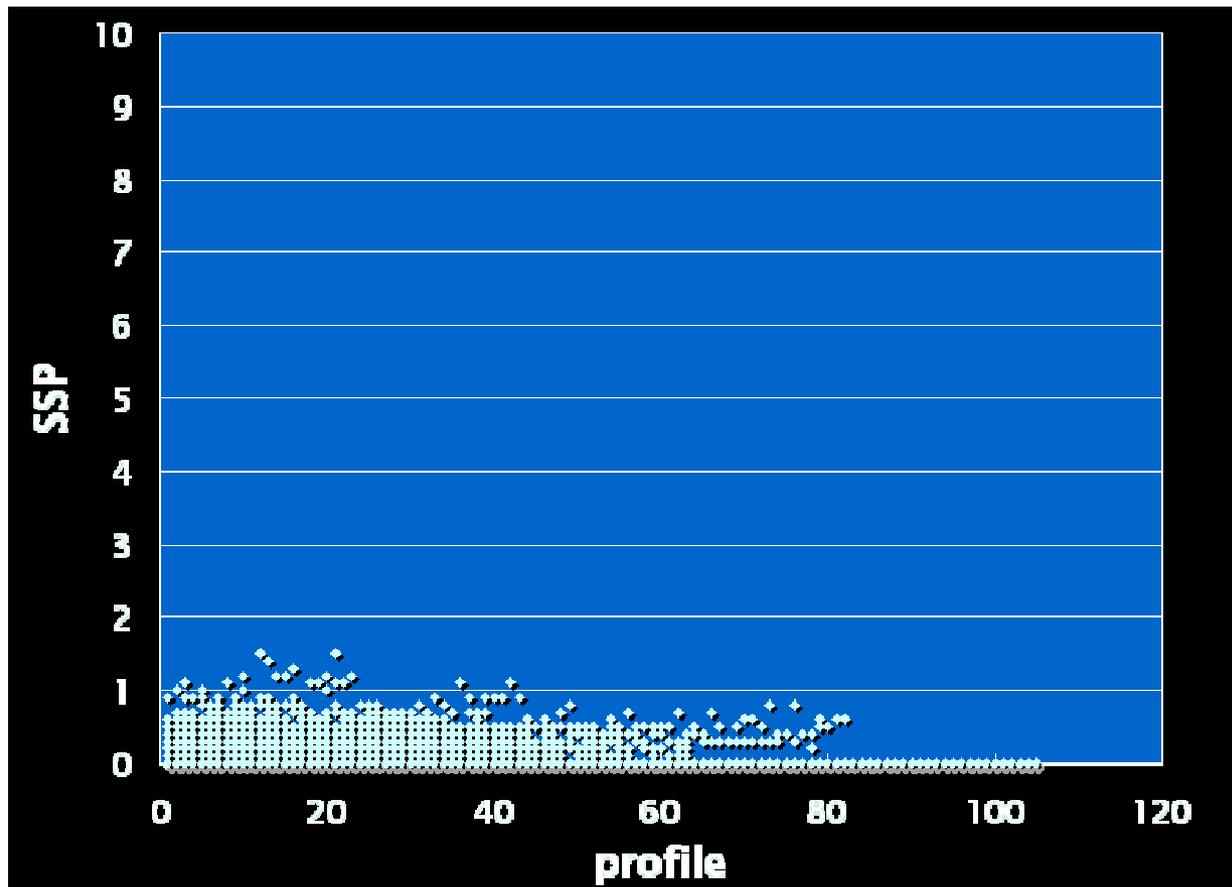
Figure 5. Reported sea surface pressure (SSP) vs. profile number from JAMSTEC Argo Floats equipped with Druck pressure sensors.

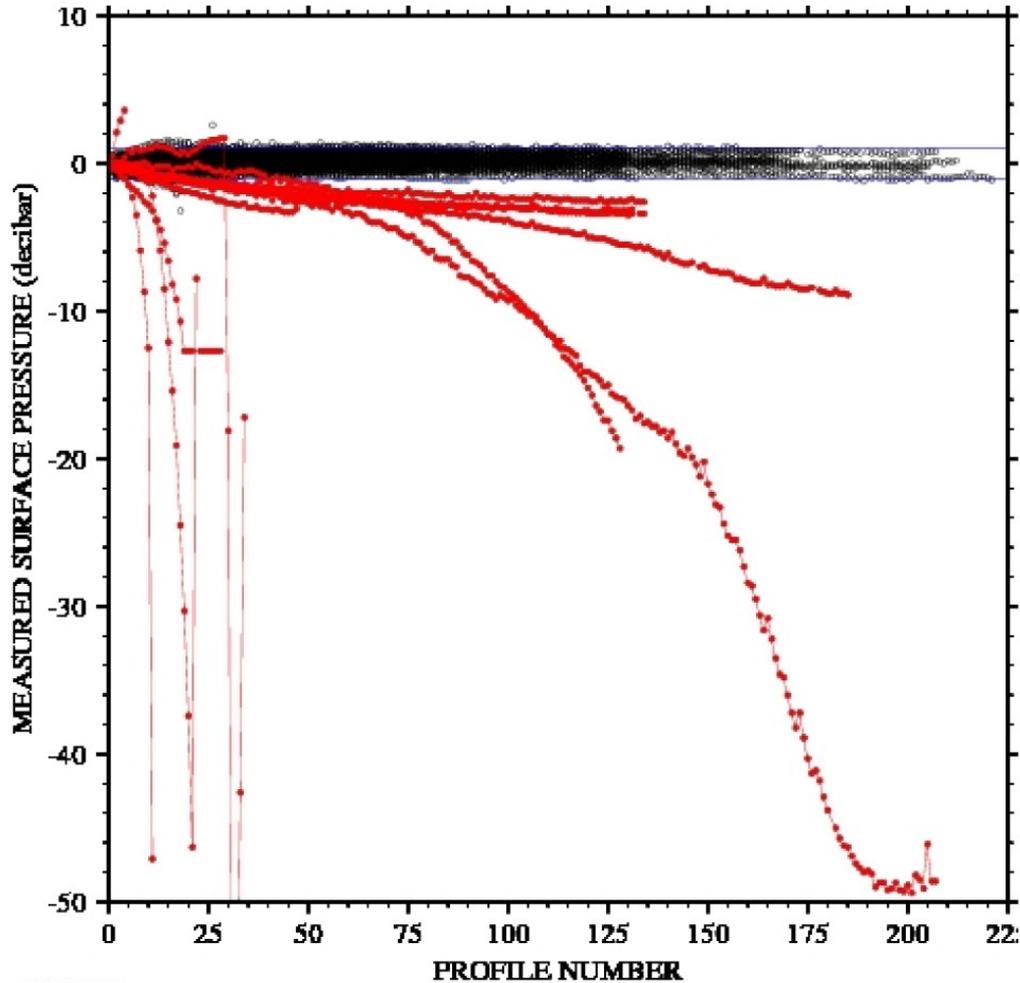
1216427:833:839654

What does the problem look like ? (Photo and data from Dana Swift, UW)

- 1) Float deployments suspended from April 2009, until a solution is found. See notices on Argo project office web site (http://www.argo.ucsd.edu/seabird_notice.html).
- 2) SBE working urgently on a solution with Druck. SBE has also been working on a new sensor with Kistler, which may be ready for deployment soon.
- 3) There is now a backlog of floats awaiting modified CTDs. When a reliable solution has been found, Argo will prioritise the deployment opportunities. This is being done with an emphasis on maintaining the global array. High-priority deployments will be first in line for reliable sensors.
